Smoke and Dye Testing Summary

High Level Sewershed

Test ID	Test Type	Date Inspected	Company / Super.	Blower MH	Ground Condition	Notification Made?	Total Length
S1028-127	Smoke	10/21/2008	ADS/TM	S09QQ_010MH	Dry	Yes	924.48

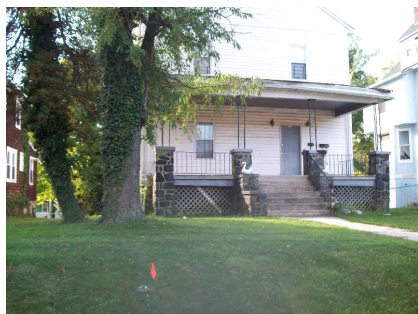
Picture \S1028-127-OB01-P01.jpg

Source Cleanout

Location Yard - front

Comments Smoke from cleanout in front yard. 3405 Bateman Ave.

Comments Front yard, 3405 Bateman Ave.

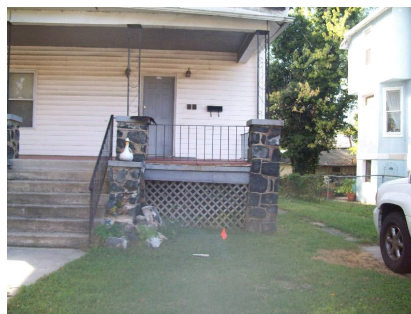
Picture \S1028-127-OB02-P01.jpg

Source Cleanout

Location Yard - front

Comments Smoke from cleanout in front yard. 3407 Bateman Ave.

Comments Front of house, 3407 Bateman Ave.

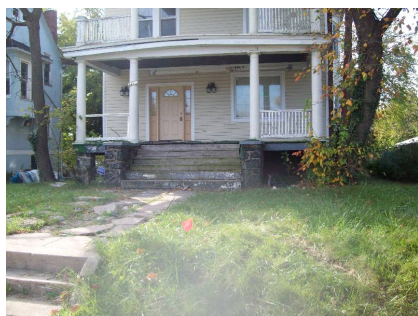
Picture \S1028-127-OB03-P01.jpg

Source Cleanout

Location Yard - front

Comments Smoke from cleanout in front yard. 3411 Bateman Ave.

Comments Front of house, 3411 Bateman Ave.

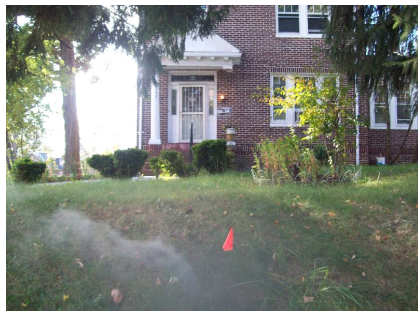
Picture \S1028-127-OB05-P01.jpg

Source Cleanout

Location Yard - front

Comments Smoke from cleanout in front yard. 3401 Bateman Ave.

Comments Front of house, 3401 Bateman Ave.

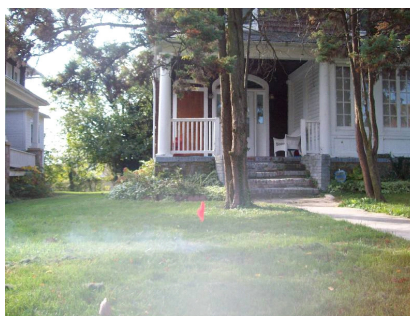
Picture \S1028-127-OB04-P01.jpg

Source Cleanout

Location Yard - front

Comments Smoke from cleanout in front yard. 3403 Bateman Ave.

Comments Front of house, 3403 Bateman Ave.

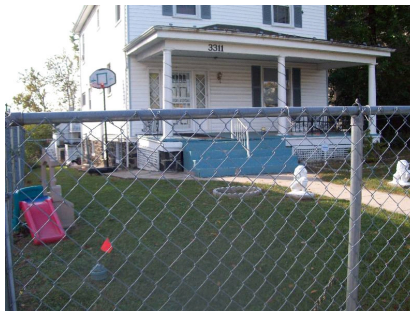
Picture \S1028-127-OB06-P01.jpg

Source Cleanout

Location Yard - front

Comments Smoke from cleanout in front yard. 3311 Bateman Ave.

Comments Front of house, 3311 Bateman Ave.

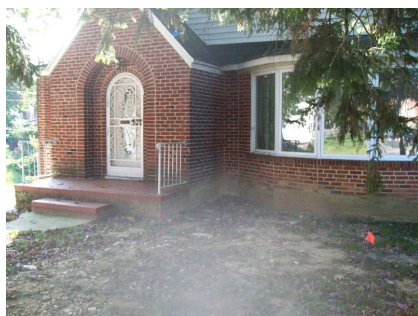
Picture \S1028-127-OB07-P01.jpg

Source Cleanout

Location Yard - front

Comments Smoke from cleanout in front yard. 3301 Bateman Ave.

Comments Front of house, 3301 Bateman Ave.
